WRF Research Efforts on Large Diameter Pipes

Water Research Foundation

Metropolitan Water District, Los Angeles, January 20,
2016

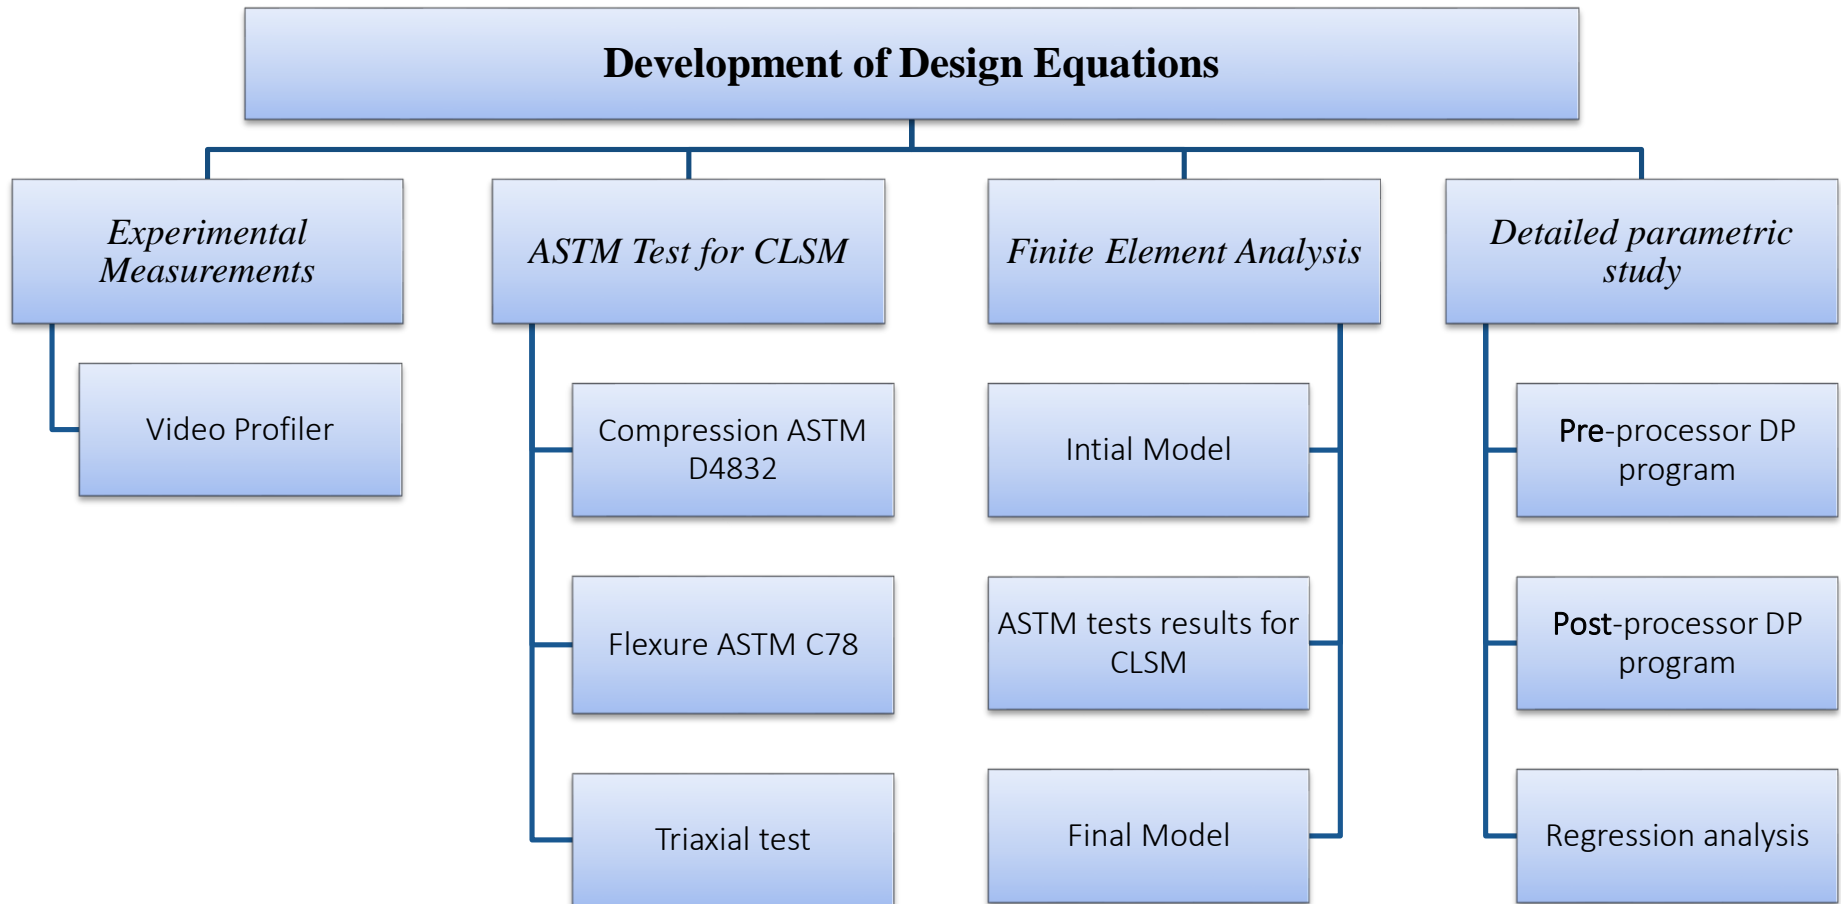
Research steps and goals

- Unique understanding of interaction of steel pipes with Controlled Low Strength Material (CLSM)
- Development of steel pipe- CLSM interaction design equations
- To accomplish:
 - Experimental testing
 - FEM simulation
 - Nonlinear regression analysis

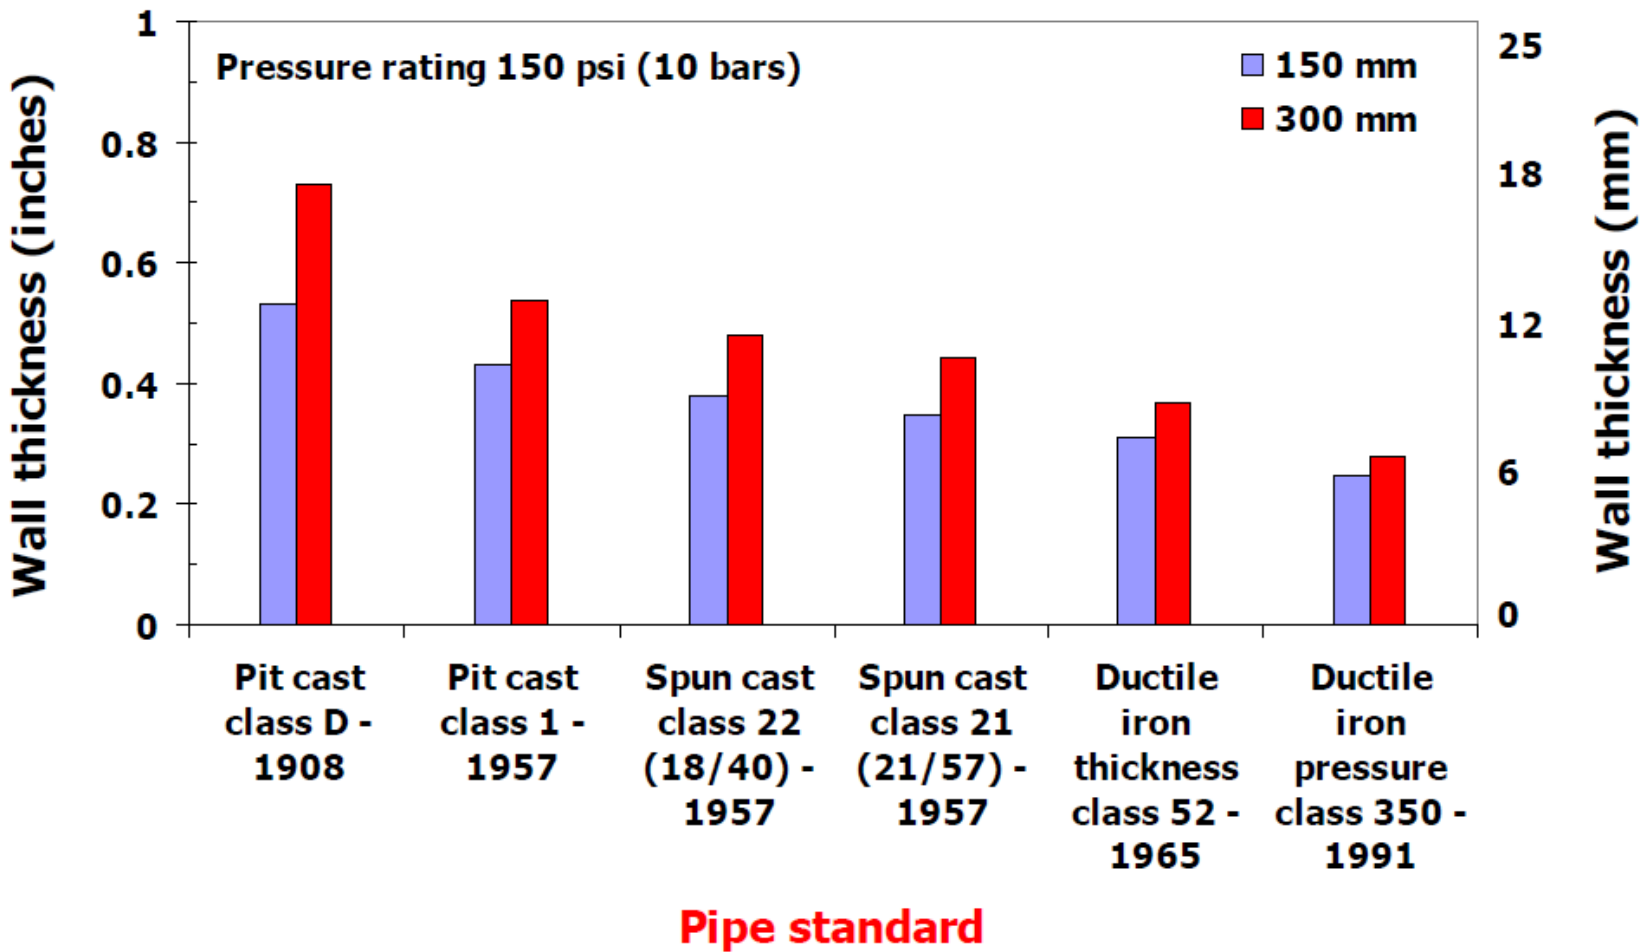
Timeline

Era	Event	Characteristics
Early 1800s	Horizontal pit-cast mass-produced	Sand moulds (two halves), 4-5' length, poor Q/C. Asphalt dip.
1850s	Vertical pit-cast introduced	Concentric sand moulds, 8-12' length, better Q/C, Asphalt dip.
1870s	Vertical pit-cast mass-produced	Bells placed at bottom. Better Q/A.
Early 1920s	Centrifugal (spun) cast with metal moulds introduced	Metal moulds - water cooling & annealing. Better uniformity & Q/C – lower wall thickness.
Mid 1920s	Centrifugal (spun) cast with sand moulds introduced	No water cooling & annealing. Longer segments 16-20'.
1930s	Centrifugal (spun) cast mass-produced	Both metal & sand moulds used. Sand for diameters >24".
Early 1970s	CI pipes no longer produced
