# LARGE-DIAMETER PIPELINE REHABILITATION

CHARLES NGO TRUNK LINE DESIGN MANAGER WATER ENGINEERING AND TECHNICAL SERVICES

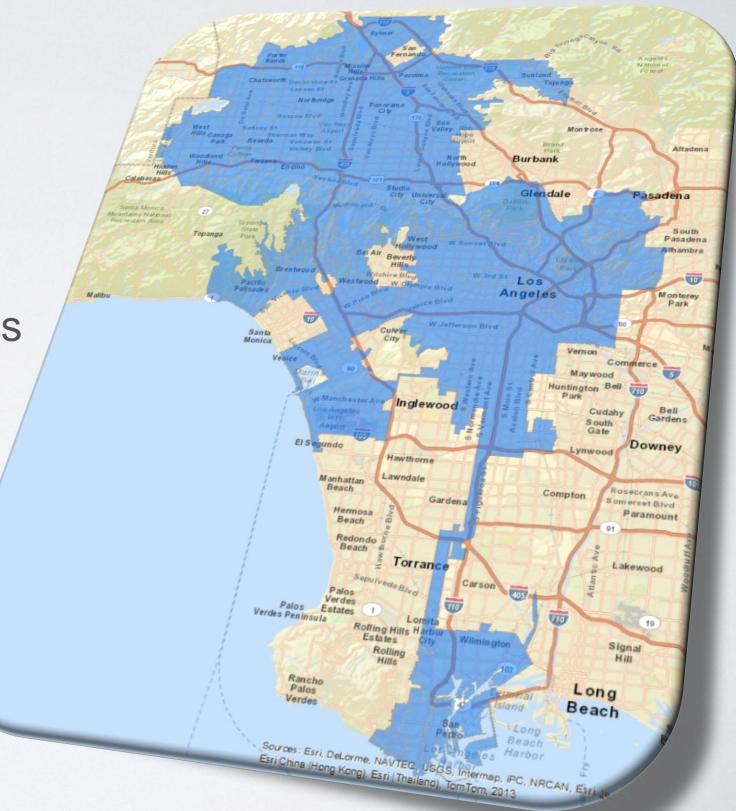
#### **Overview:**

- 24 in. diameter & greater
- 542 miles in total length
- In the next decade, 120 miles (22%) of TL's will reach their useful life of 100 years
- Average replacement rate from last 10 years is 2.6 miles per year
- At this rate, the replacement cycle is almost 210 years

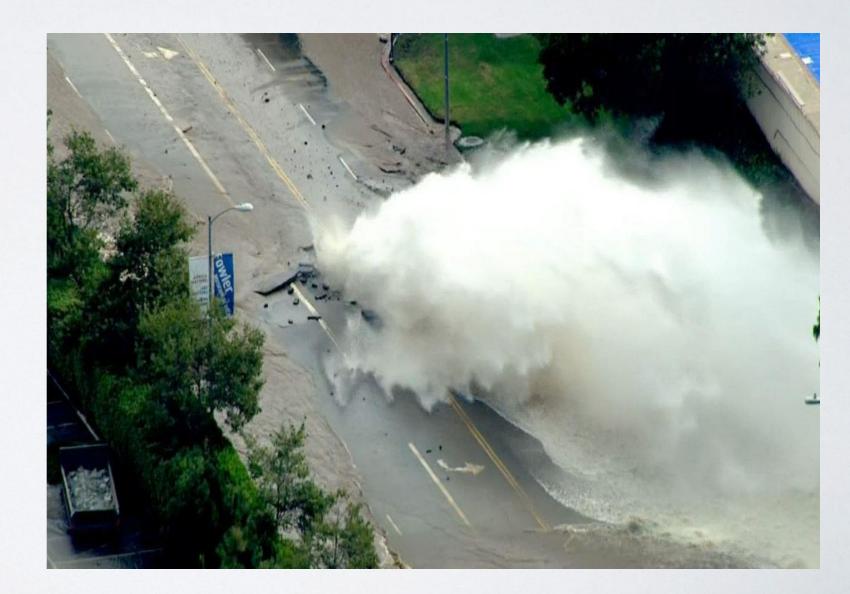
### Likelihood of Failure (LOF) Factors

Leaks
Pipe Materials
Service Life
Soil Corrosivity
Water Pressure

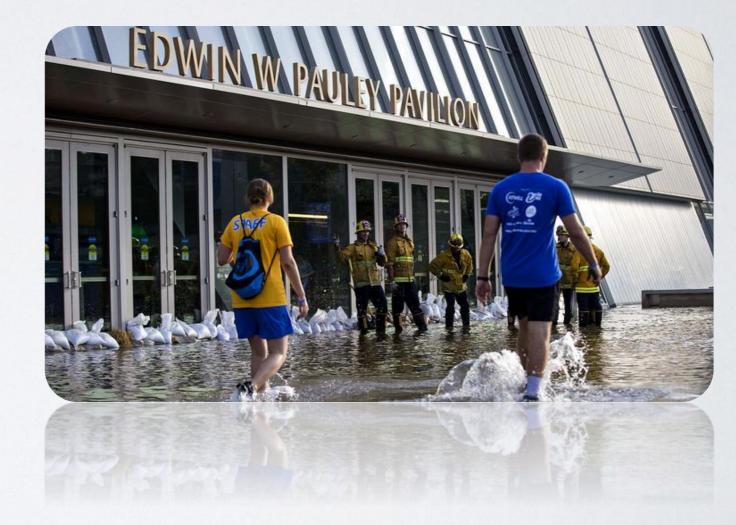
### Consequences of Failure (COF) Factors

- Community Safety, Health, and Welfare
- Environmental and Traffic Impacts
- Repair Costs
- Lost Revenue
- Critical Customers
