San Diego County
Water Authority

MANAGING A PCCP REHABILITATION PROGRAM

WATER RESEARCH FOUNDATION – LARGE PRESSURE PIPE
STRUCTURAL REHABILITATION CONFERENCE

Nathan Faber, P.E.
Operations and Maintenance Manager
January 20, 2016

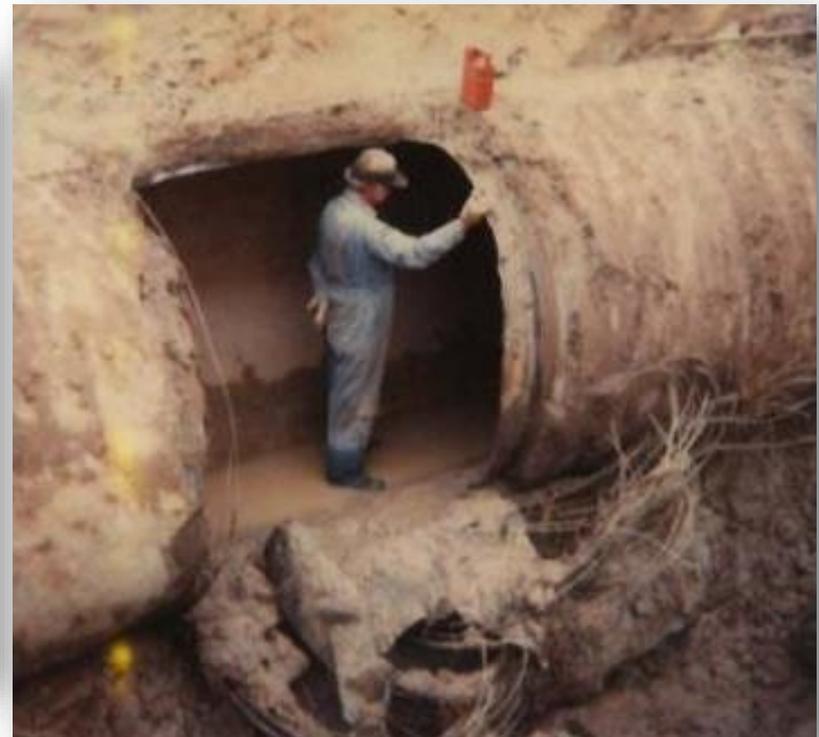
Pipe Damage

Pete Rios, public information officer for the San Diego County Water Authority, said the force of the water from the pipeline excavated a hole 20 feet across, 30 feet long and at least six feet deep.

Rios said no one was injured when the waterline burst and that water flow was brought under control in a matter of minutes through the use of valves along the line and at the reservoir. Repair crews, operating with cranes, chipping equipment and bulldozers, were removing a 20-foot section of damaged line and will replace it with a new one.

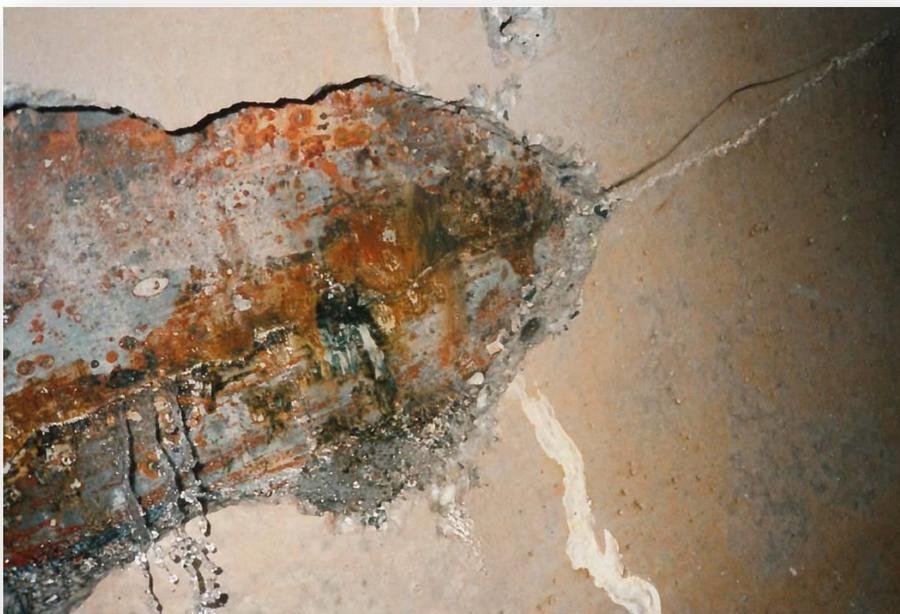
Internal - Cylinder Leak/Corrosion

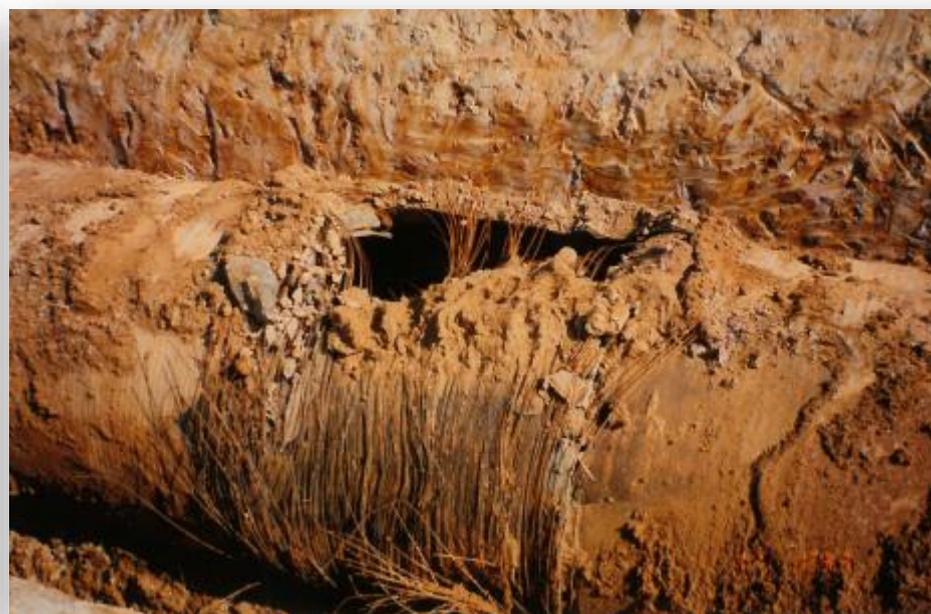
Damaged Pipe

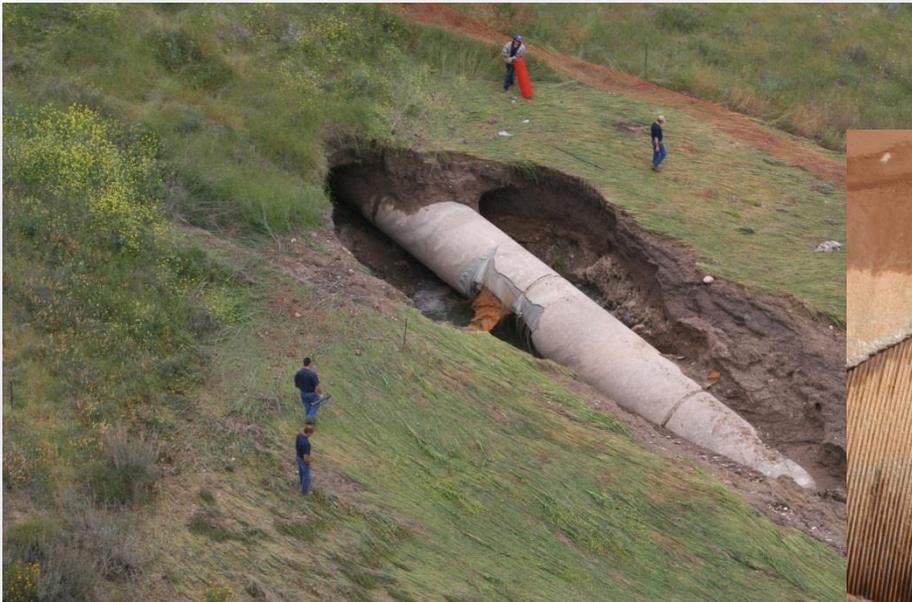
Erosion Damage

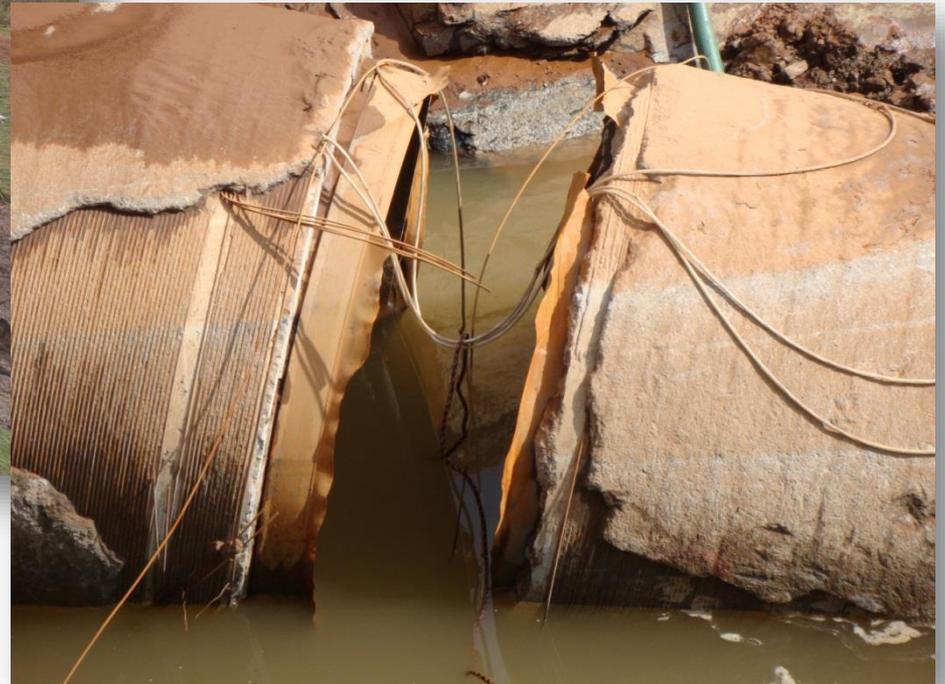
Pipe Damage at Joint

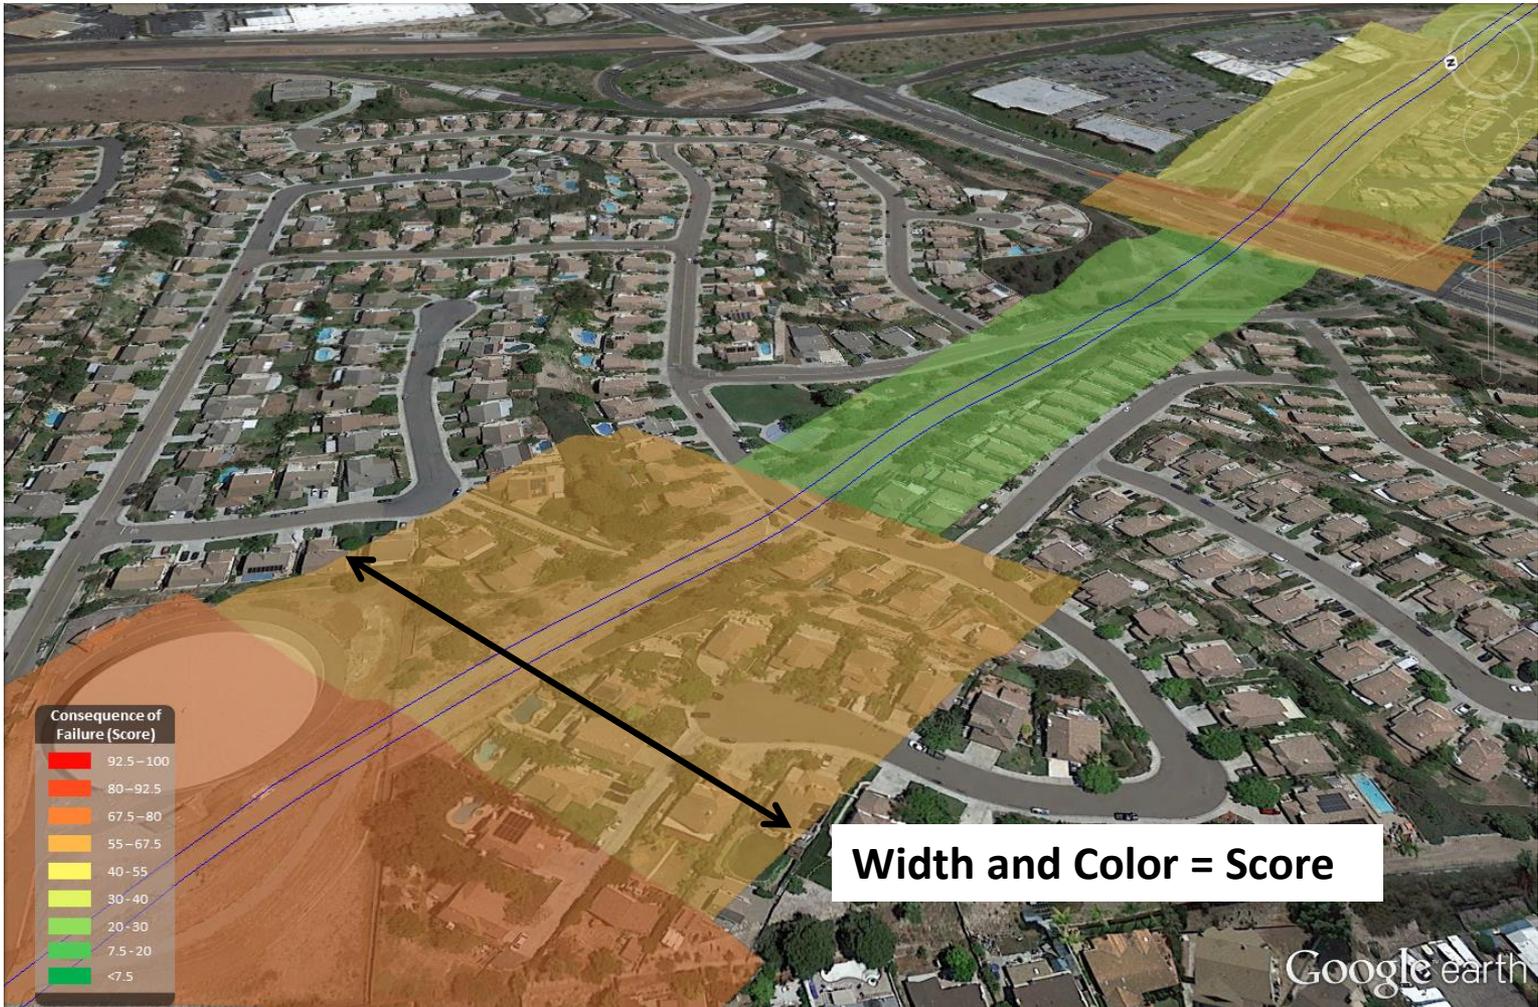
CONSEQUENCE OF FAILURE (3D)

CONSEQUENCE OF FAILURE SCORE

1. Location
2. Other Utility Infrastructure
3. Water Authority Pipes

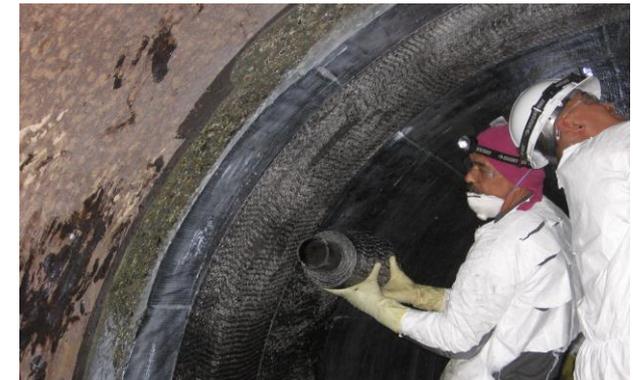
Carbon Fiber Repair

1. Large Scale Rehabilitation
2. Section Repairs
 - Long Term (Steel Replacement)
 - Short Term (Carbon Fiber Repair)
