# DISTRIBUTION SYSTEM MANAGEMENT

Water Quality

## Understanding Deterioration of Water Quality in the Distribution System

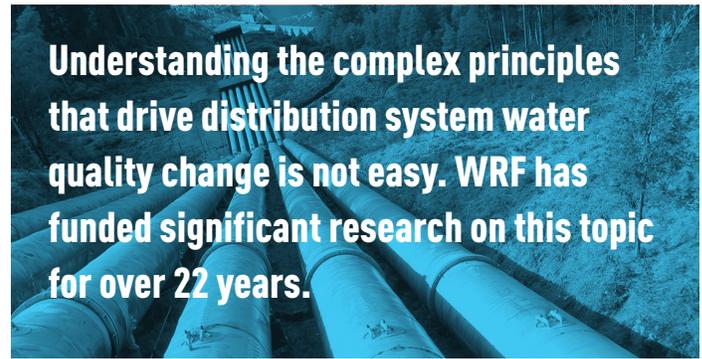
The deterioration of water quality in a distribution system is complex and can be caused by multiple mechanisms (Figure 1). Factors affecting water quality include internal corrosion and leaching of chemicals, accumulation and release of contaminants, biofilm formation and bacterial regrowth, and physical and chemical processes that occur in the pipe. (EPA 2006, Sadiq et al. 2009)
